HS ALERT

Incident /Hazard	UV Burn from Transilluminator
Incident	Prolonged exposure to UV light from transilluminator resulted in both eye and facial burns
Date	19/10/2012

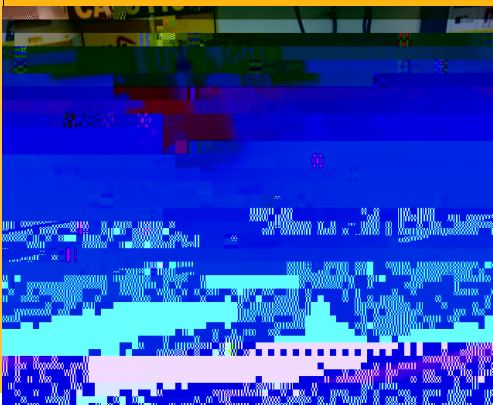
A lab worker received significant eye and skins burns from over-exposure to UV while working adjacent to a UV transilluminator.

On 19th October, two lab workers were using a transilluminator to view DNA/RNA that had been separated by electrophoresis. In addition they were cutting out the bands that form on an agarose

An appropriate documented safe work procedure was available for the task. A hazard warning sign was displayed adjacent to the equipment. Two sets of UV rated protective face shields were available but only one had obvious signage indicating its suitability for transilluminator use. The injured worker mistakenly believed that this face shield was inadequate to protect against the hazard and thus did not wear it. She further believed that as she was not working directly under the UV light (rather she was working adjacent to the instrument), she would not be at risk.

1. Ensure that all workers in the vicinity of the transilluminator are sufficiently aware of the hazard regardless of whether they are using the equipment or not.
2. Ensure a UV rated shield is installed around the equipment to protect workers who are working adjacent to the equipment particularly where the fixed shield cannot be used .
